Manhole Inspection Summary

Manhole # S45K__026MH

Insp Date: **4/29/08 1:36 PM**

Location Address: **628 s wolfe st**

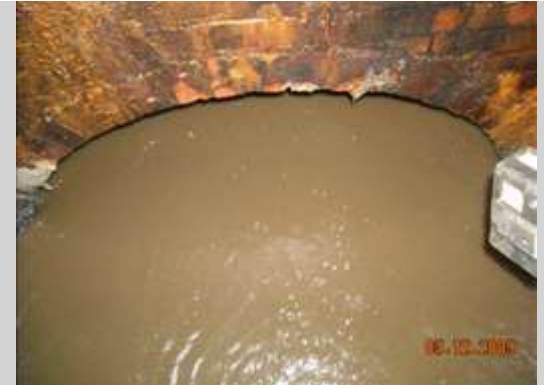
12 O'Clock Outflow

48 in. Circular Gravity Sewer
Pipe Out @ 12 O'Clock

Pipe Material: **Concrete** ☐ Pipe Lined

Invert Depth: 17.00 (ft.) Flow Characteristics: **Fast**

Infiltration: **None** Pipe Seal Cond: **Unknown**

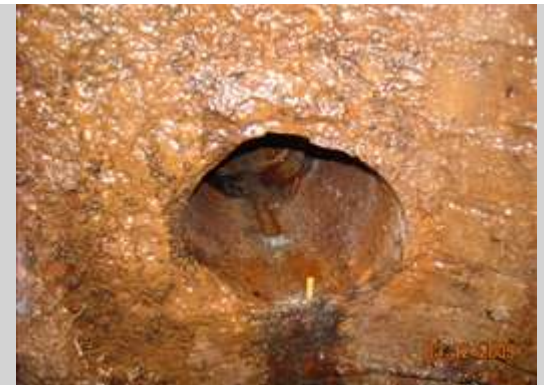
3 O'Clock Inflow

8 in. Circular Gravity Sewer
Pipe In @ 4 O'Clock

Pipe Material: **Clay** ☐ Pipe Lined

Invert Depth: 10.60 (ft.) Flow Characteristics: **Fast**

Infiltration: **None** Pipe Seal Cond: **Unknown**

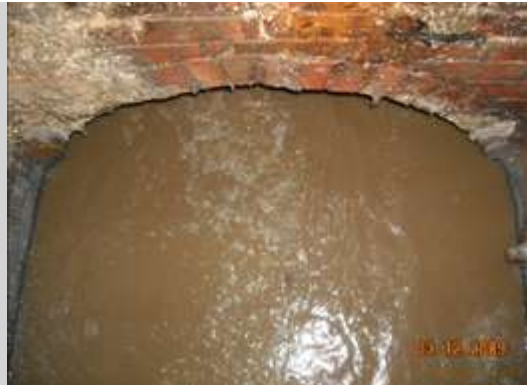
6 O'Clock Inflow

48 in. Circular Gravity Sewer

Pipe In @ 6 O'Clock

Pipe Material: **Concrete** ☐ Pipe Lined

Infiltration: **None** Pipe Seal Cond: **Unknown**
